Overview of the 2006 Annual Surveillance and Maintenance Report (Including 4th Quarter 2006) for the DOE LM Rocky Flats Site

Rocky Flats Stewardship Council

May 7, 2007

Annual 2006 Site Surveillance and Maintenance

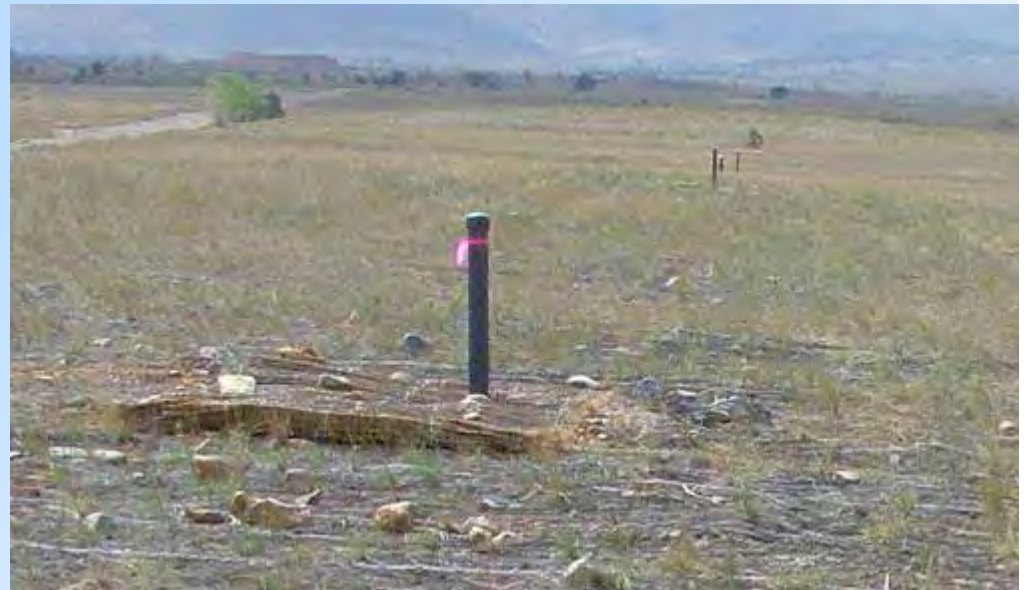
- **Present Landfill - Settlement Monuments**
 - 9 monuments across top of landfill
 - 6 monuments on east face of landfill
 - Installed in August
 - All monuments surveyed in December

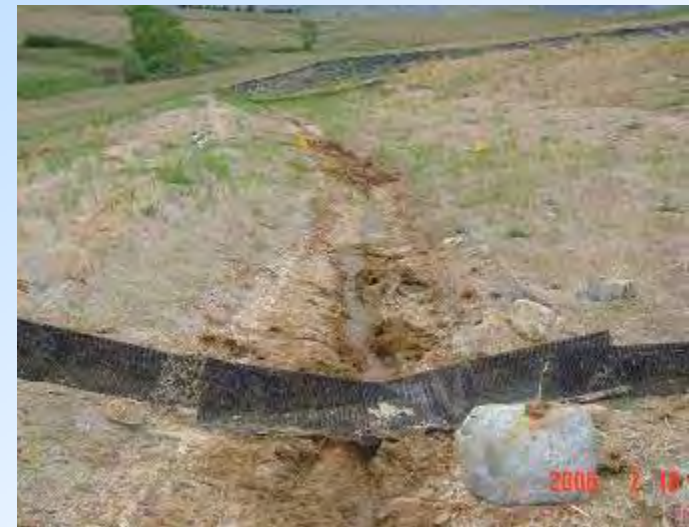
- **Original Landfill Seeps and Slumps**
 - Seep #7
 - Investigation of “burrito drain”
 - Seep #4
 - Shallow trench dug to the West Perimeter Ditch
 - West Perimeter Ditch slump
